FIELD TRIP INFORMATION

WIEPRZÓWKA AND STRYSZAWKA STUDY AREA

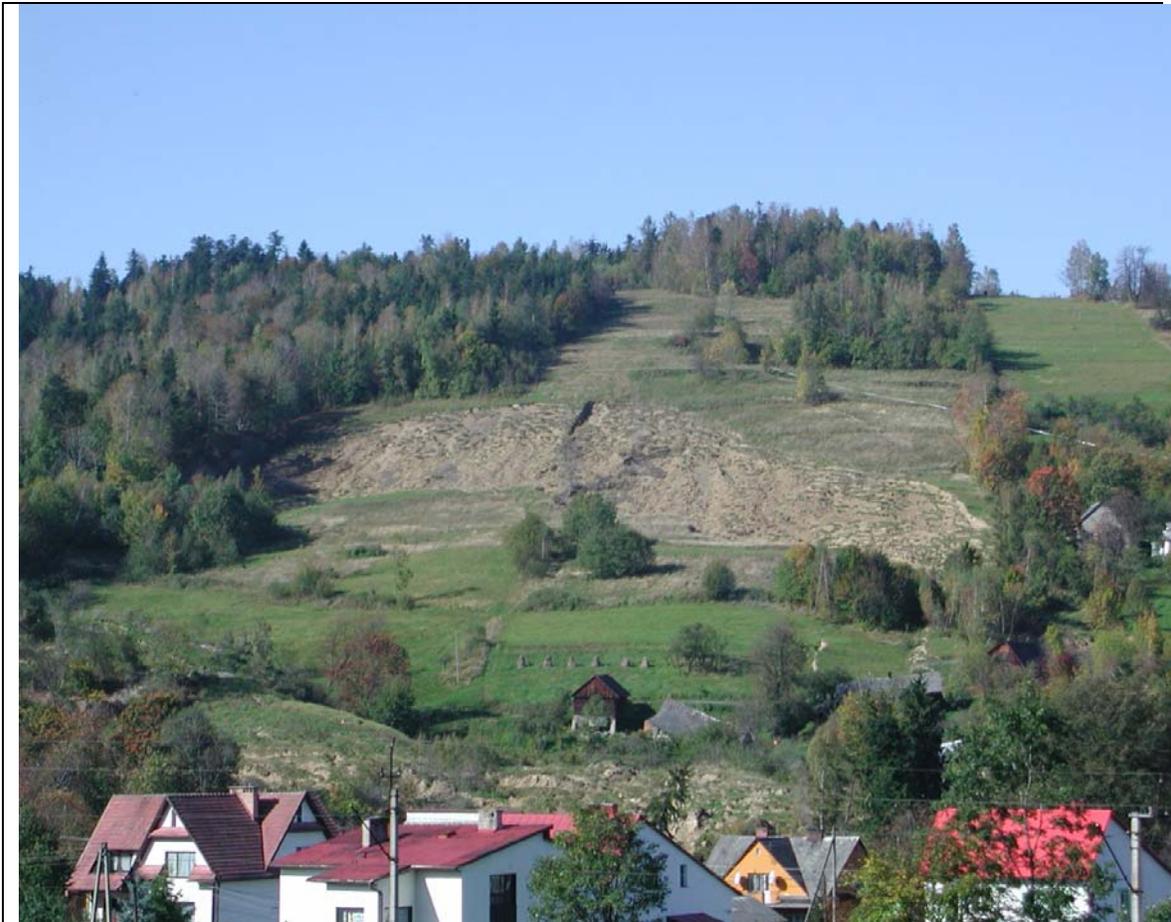
Photo 1. Landslide in Lachowice - autumn 2001 (courtesy of W. Rączkowski, PGI)

It was on 27 July 2001, when long-lasting and heavy precipitation (extreme recorded monthly totals), caused a spectacular slope failure and rejuvenation of an old **landslide**. The new form developed in the SW portion of the Pierchałowa Mt., while rejuvenation occurred mainly in the NE portion, affecting the total area of ca. 11.7 ha (Photo 1).

The new landslide was delimited by an arcuate main scarp (roughly 1.5 m high) and by a steep (up to 7 m high) wall at the western lateral flank. The lateral cracks (1.5 m deep) formed at the north-eastern flanks and set the limits of a 10–20 m wide trough. Depleted rock and earth masses were transferred ca 60–70 m downslope within a dozen of minutes. The tongue dammed the Lachówka stream channel. The colluvial material was removed from the stream to preserve drainage, so a potential flooding was avoided.

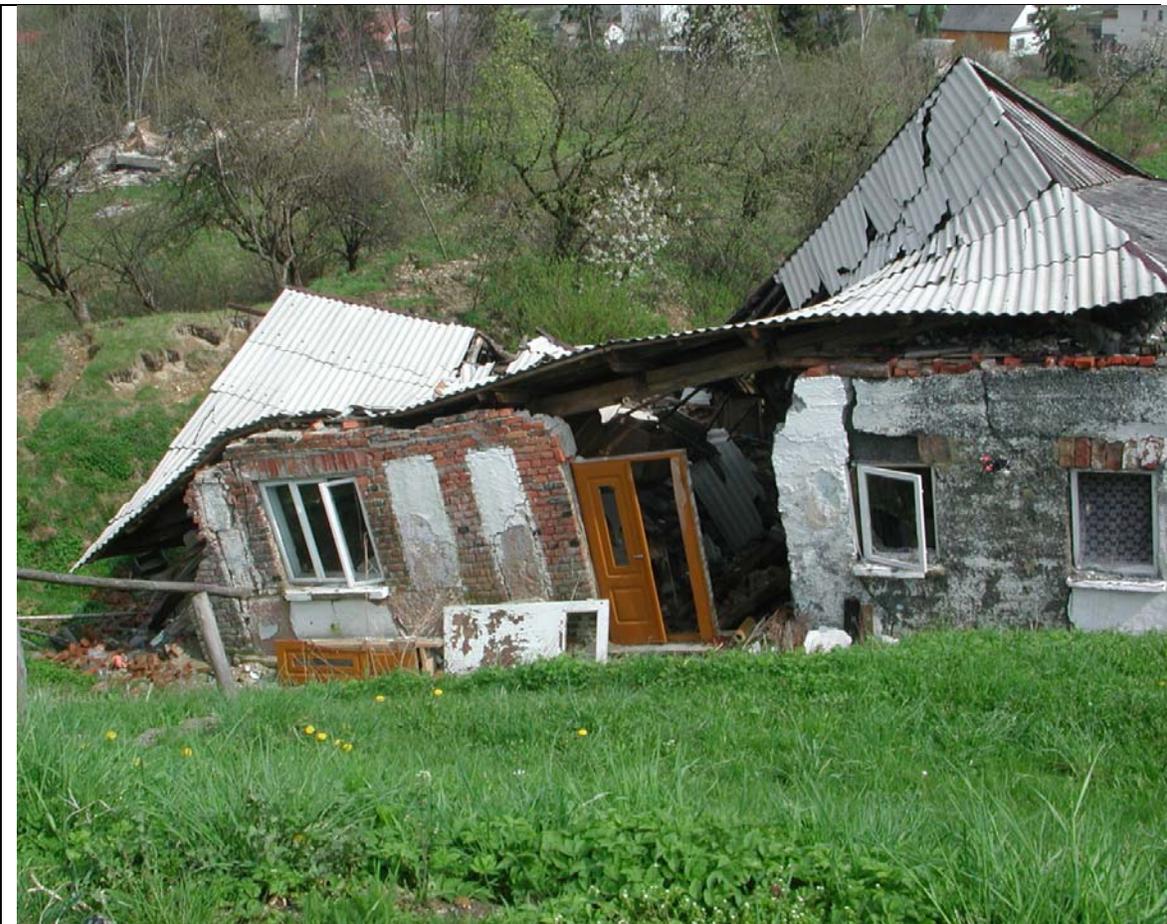
Photo 2. Landslide in Lachowice (spring 2002) - damaged houses (courtesy of W. Rączkowski, PGI)

Although the mass movements in Lachowice did not result in any casualties, the structural damages were vast. In the first phase of landsliding 12 houses were completely damaged (Fot. 2) while next 38 were endangered. The entire affected region required reclamation – nowadays 2/3 of the area is reforested. The total cost associated with transferring infrastructure out of the landslide area and with mitigation measures exceeded 2.5 million PLN.

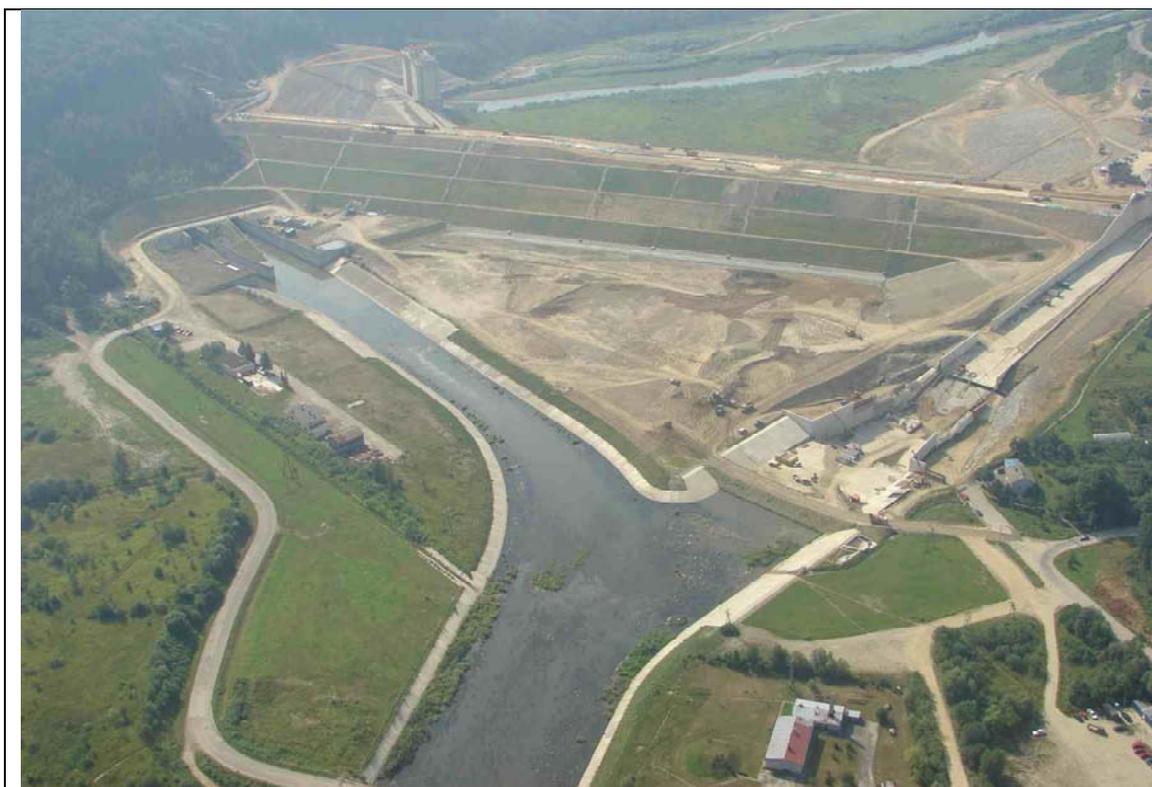
Photo 3. View to Świnna Poręba dam from the air-side - (courtesy of RZGW Krakow)

The dam is built of gravel material and made tight with a clay core. It is protected with concrete panels on water-side.

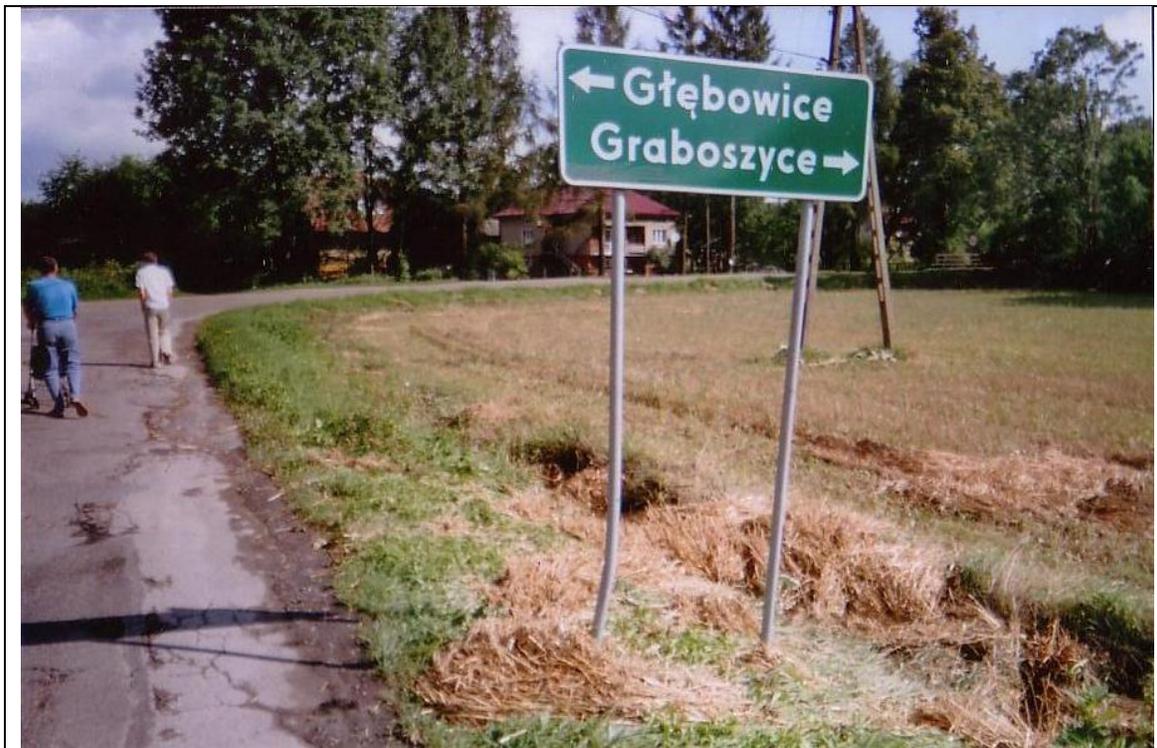
Photo 4. Traces of the flash flood 24/25 August 2005. (courtesy of W. Głowacki, IUD)

In the first draft of the plan applications had been rejected as the area was considered flood-endangered. A bit later water board delivered data according to which, the area seemed to be safe. When the municipal council was close to the approval of the final version of the plan the flash flood occurred in the night 24/25 August 2005. Water from Wieprzówka flew over the road to Frydrychówka stream leaving a bunch of straw on the bent signpost.

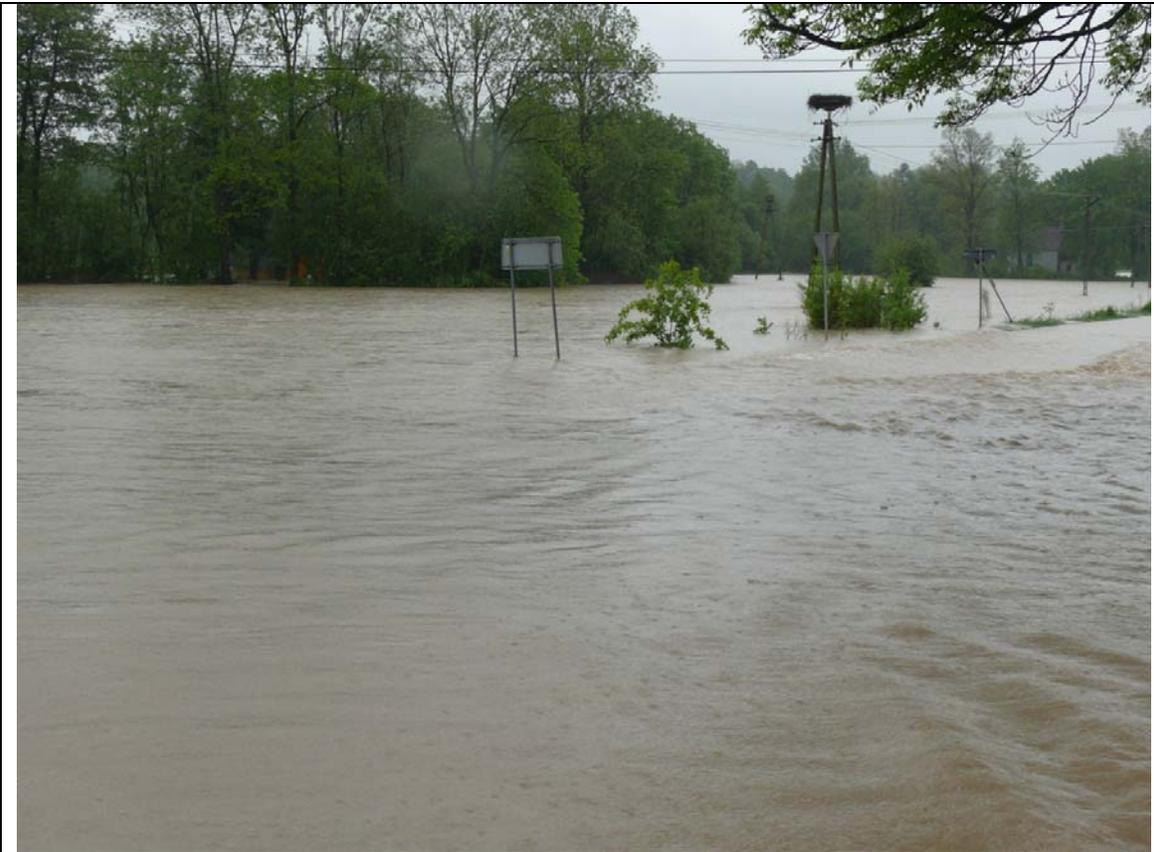
Photo 5. The road from Frydrychowice to Przybradz flooded in spring 2010. (courtesy of Wieprz Municipality)

This way the dispute about the extent of flood-endangered areas was settled down. Development applications were rejected. Next flood in spring 2010 also flew over the same road.

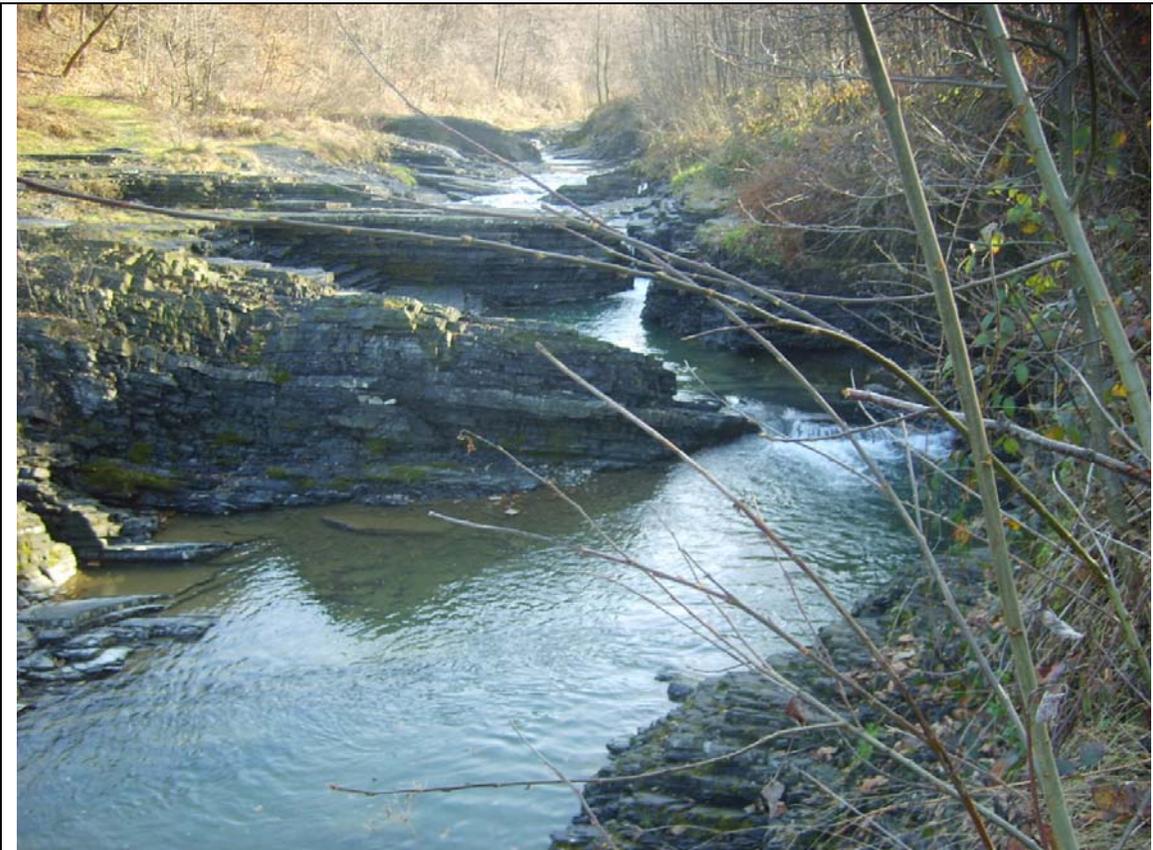
Photo 6. The Wieprzówka gorge, spring 2010. (courtesy of W. Głowacki, IUD)

In mid 80s however the flood destroyed stone-built constructions. Alluvial sediments were removed by subsequent floods. Background rock has been uncovered. It turn out to be a thick layer of dark schist (wierzowskie schist). Fluvial erosion progressed easily in soft rock and the riverbed has been deepened during following years. This way Wieprzówka gorge emerged in its current form. Relics of old embankments hanging 4-5 m above the watertable indicate the level of the river from the beginning of 80s.
