<b>Protocol KICK-OFF MEETING</b> <b>Case Study Friuli Venezia Giulia Region – Fella River</b> <b>Pontebba, Dec 13th 2011</b>			
Date and Time:	13.12.2011/ 9.00h-12.00h		
Venue:	Meeting room – Civil protection Agency – Pontebba, Italy		
Objectives	1- Discussion with personnel of Civil Protection on data availability and modelling techniques for the flooding phenomena on the Fella River 2- Discussion with personnel of Civil protection on their initial expectative from the interaction with CHANGES project 3- General overview to some of the critical points in the Fella river before the meeting and then visit to some of the main interventions after the last flood event in August 2003		
Participants:	Claudio Garlatti (CPA-CG)	Civil Protection Agency	Partner and stakeholder
	Primiero Aldo (CPA-PA)	Civil Protection Agency	
	Alessandro Pasuto (CNR-AP)	CNR-IRPI, Padova - Italy	CHANGES project team
	Simone Frigerio (CNR-SF)	CNR-IRPI, Padova - Italy

Report prepared by V. Juliette Cortes (ESR 10, CNR-IRPI Padova) on December 20<sup>th</sup> 2011 with inputs from the CHANGES team.

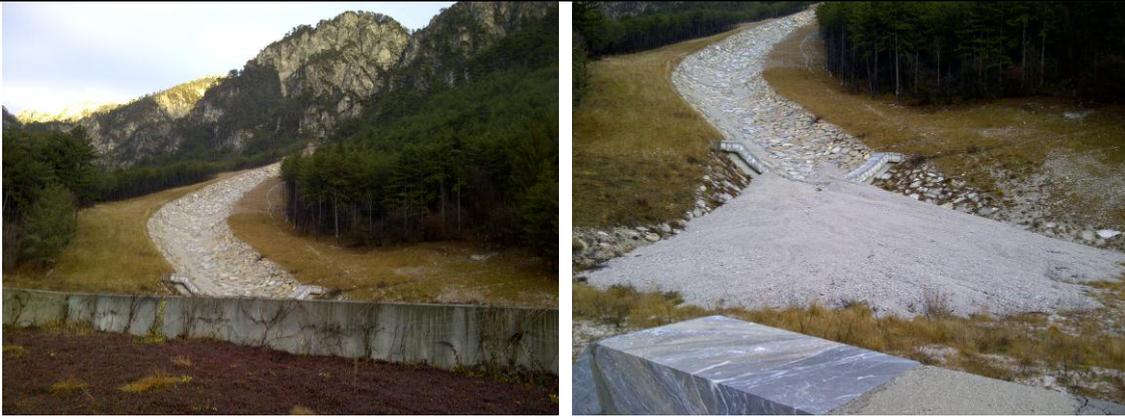
**Figure 2 and 3** Conformation works for slope stabilization along debris flow channel in the Malborghetto village, December 2011.

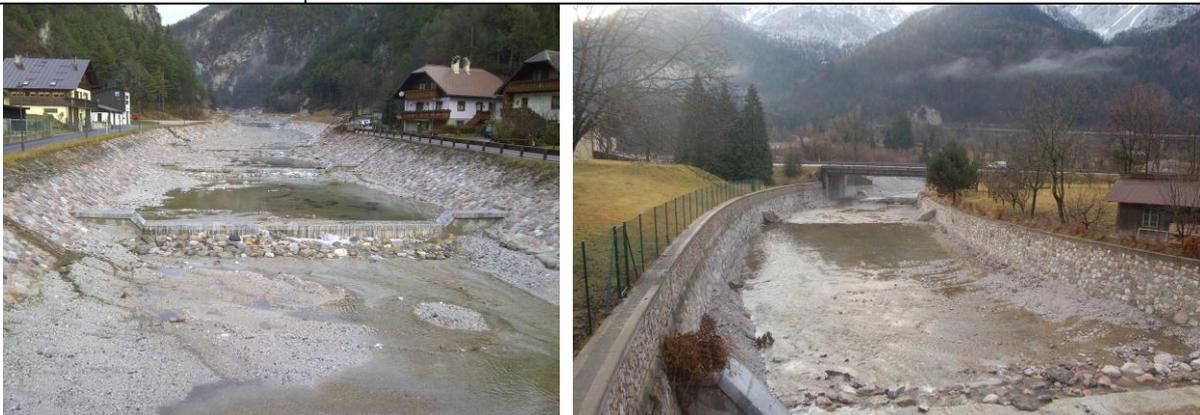
Although the capacity of the bridge is enough from the hydraulic perspective, it is still prone to flash flood after intense precipitation events due to the high sediment mass mobilized and deposited in the cross section, which reduce its hydraulic capacity.

Moreover, in extreme events as the one experienced in August 2003 the sediment transported could cause a significant stream widening and incision in the channel. After that flood event hydraulic works were carried out approx. 3km upstream of this point in the form of grade-control structures, with the aim of stabilizing the channel and trap sediments. **Figure 4 and 5** (as taken from the bridge), show the type of sediments accumulated in the bottom of the channel and the works carried out by the CPA after the flood event in August 2003.

**Figure 6.** (Left) Bottom of the channel in Malborghetto stream. December 2011.  
**Figure 7.** (Right) Conformation works along the stream. December 2011.

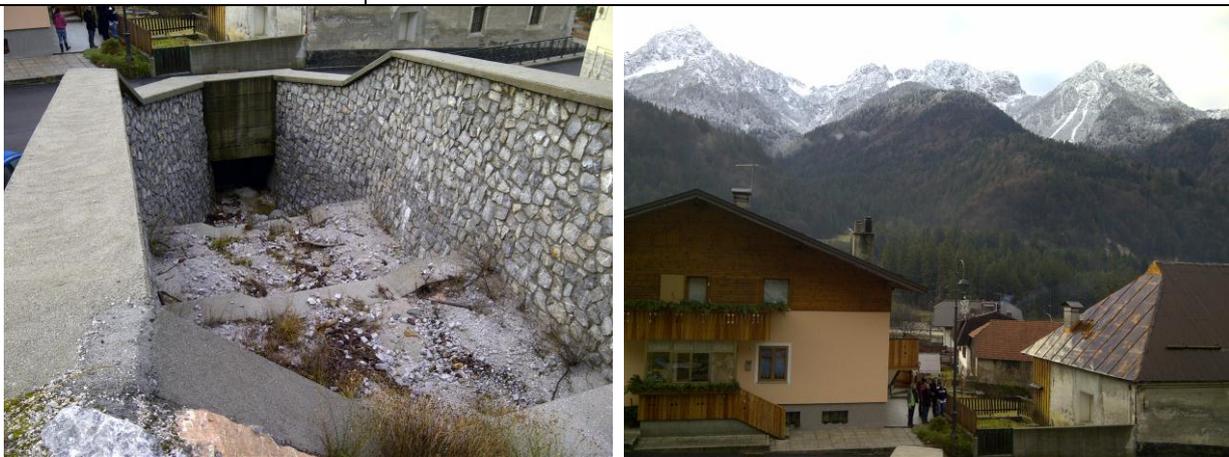
Its relevance concerns to the proximity of Malborghetto downtown considering that in the 2003 event the church and the houses next to the structure were hardly affected, with a level of sediments that reached the first level of the houses and caused one human lost.

As part of the first works after the 2003 event, removal of the materials and restoration of the hydraulic regime was done. Later combined with the construction transverse structures (filtering check dams) mainly used to prevent stream bed erosion, while longitudinal structures (run-off channel) was used to control bank erosion. Upstream these structures a small depositional basin in reinforced land was constructed as a measure for temporary debris retention and bed load management downstream. (See figures bellow) This concept allows the passing of some smaller sized particles while large boulders with high destructive potential are retained (Huebl J and Fiebiger G, 2005). Because of the high slide slope with consequent high impact of debris flow over the body, the structure needed special foundation with high wings in an area; techniques too invasive were not recommended due to environmental impact (GL-IRPI). Also it needs regular maintenance for a better operation.

**Figure 8 and 9.** View from the upstream (left) and downstream (right) point of the structure which reflects the vicinity to the downtown of Malborghetto and the transverse and longitudinal structures along the channel before it is conducted to the main river. December 2011.

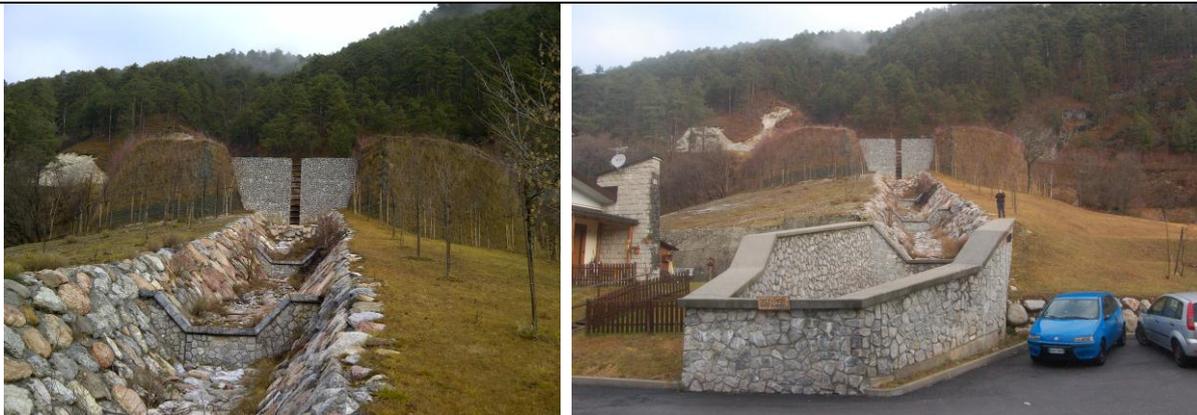
**Figure 10 and 11.** Overview of the hydraulic structure and the debris dam in which it can be appreciated the high slope of the terrain. Upstream the dam the channel is long enough to accumulate and important load of sediments that are temporary stored and later released when the tailwater is deficient of area sediments. It requires regular maintenance works after after medium and large size events. December 2011.

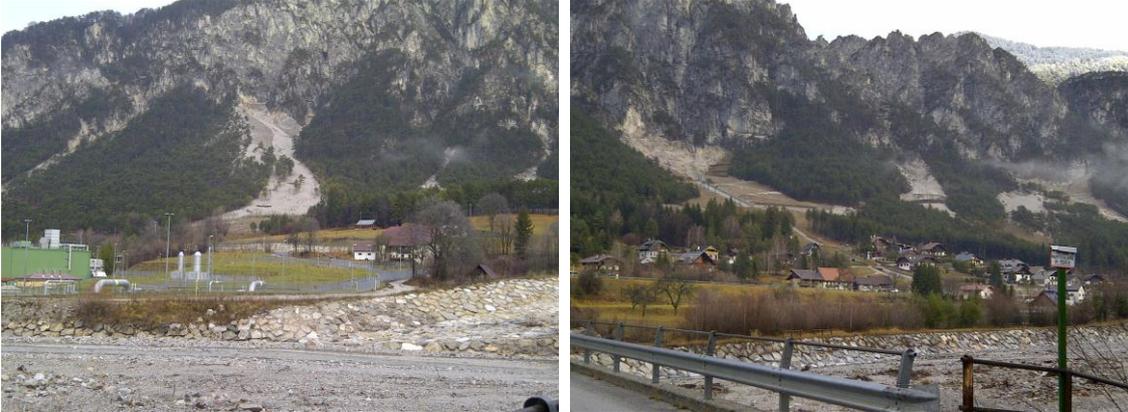
At this point a touristic village is located in the debris fan on the right hand of the confluence of the Cucco stream with Fella river; and a gas natural reserve has the pipeline next to the floodplain for the streams. Protection measures were carried out to protect three debris channels (one of them merged from two channels before the confluence) that turn into the Fella and were highly affected during the 2003 event. According to Marchi et al (2009) the major geomorphic impact of the flood was the enlargement of the active channel network, the channel and bank erosion observed along the channel network. This enlargement finally caused the collapse of the banks and a large load of sediments into the main river.

Several interventions were carried out by the CPA at this point. First to remove all the material deposited after the event, then to restore the hydraulic structures at the SS13 along the Rio Cucco and retain debris; which also imply regular maintenance. The basin has been planned for an amount of debris close to 130000mq, all mitigation measures have been concluded. The figures below give a current overview of the area from the bridge over the Fella.

**Figure 12 and 13.** View of the three main debris channels that converge into the Fella river, one natural gas reserve and the other two surrounding the touristic village. December 2011.

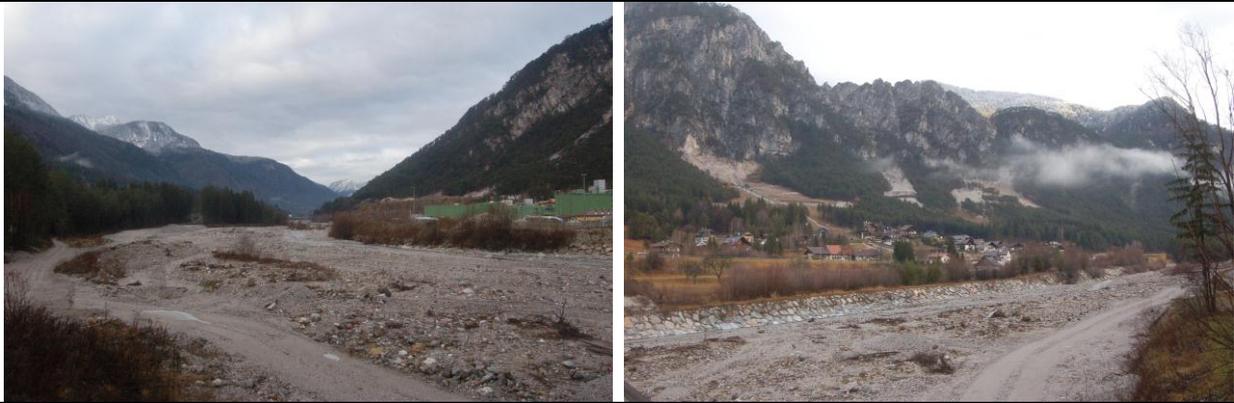
**Figure 14 and 15.** View of the Fella river upstream (left) and downstream (right) in which is evident the large amount of transported sediment that are visible due to the low water level conditions. December 2011.

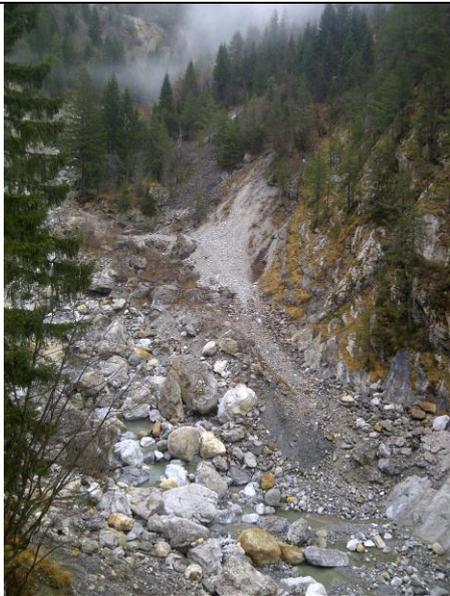
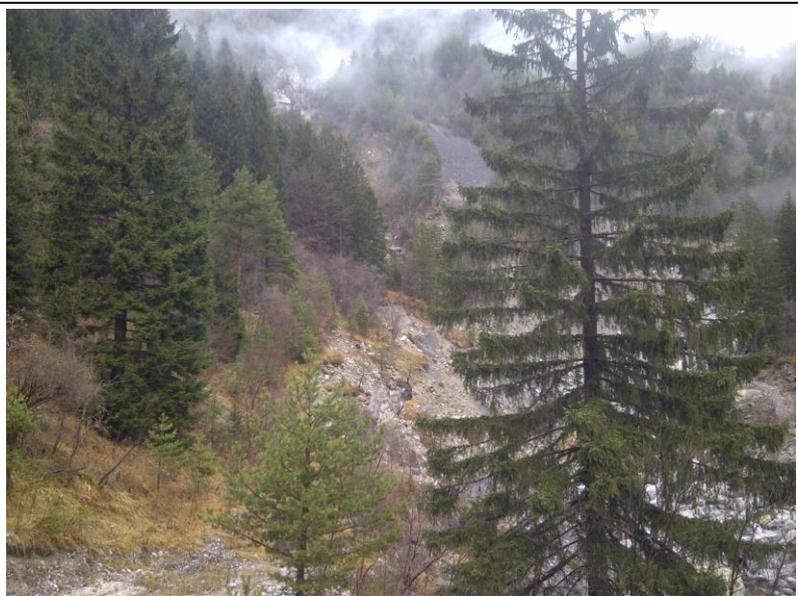
At this point Bombaso stream is mainly affected the front of a deep seated gravitational slope deformation that could be triggered not only for short and intense rainfall events but also for long time rainfall. Scenarios of secondary landslides blocking the stream with different rainfall events and conditions of break dams could be consider in order to assess the risk over the Pontebba downtown which is located nearly 1km distance in the stream lenght. GL-IRPI suggested as a reference the author C Calligaris for scientific work that analyses the interaction landslides-flood events. One of the author's publications on the study are is: Rheological investigation and simulation of a debris-flow event in the Fella watershed MA Boniello, C Calligaris - Natural Hazards and Earth sciences, 2010

**Figure 16 and 17.** Upstream view of the Bombaso stream in which the seated gravitational slope deformation. December 2011.

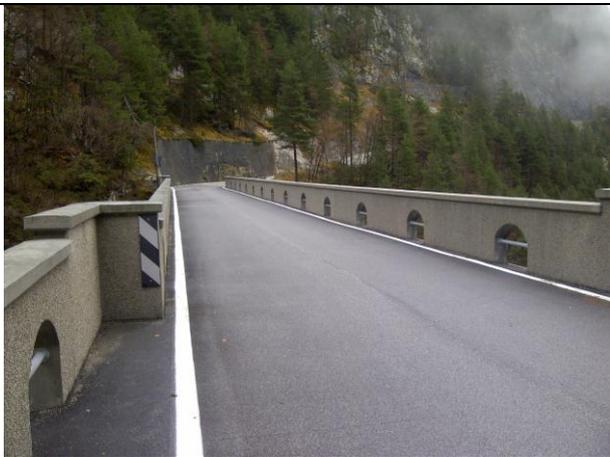
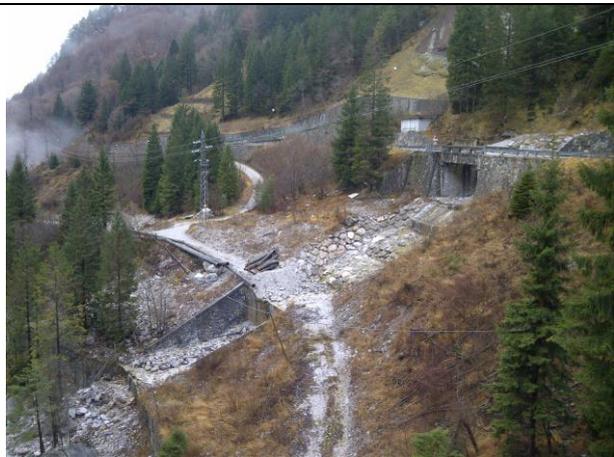
The road that passes over this stream connects turistic sky areas in the Austrian side with the italian side. Long time ago studies to connect the sky areas on the Austrian and Italian side were consider through a cable way, but it was never carried out due to their high cost. Additionally, there were intentions to replace the road by a tunnel connection, but considering the gravitational movement along the mountain the works were also abandoned.

**Figure 18 and 19.** View of the bridge over the stream and the downstream section nearly 1km from the Pontebba town. December 2011.

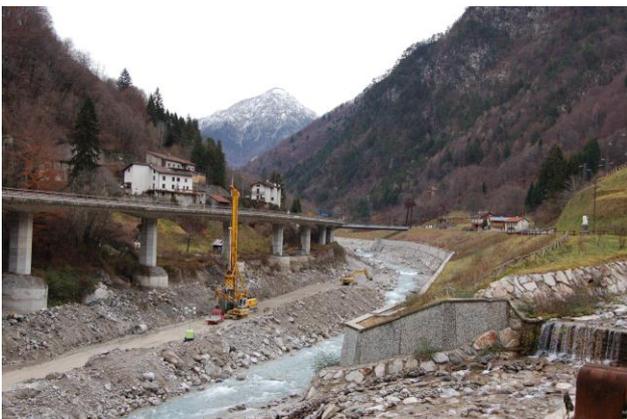
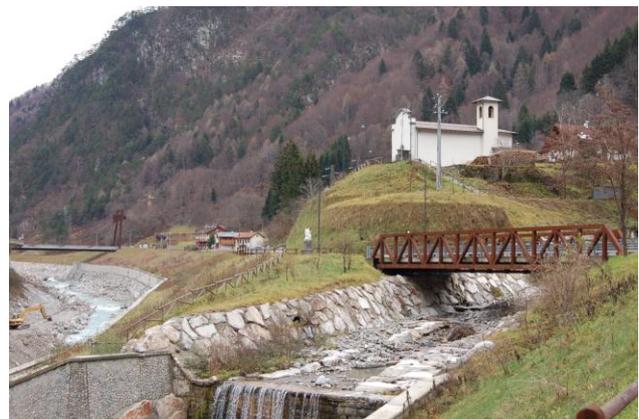
<b>STAGE 3:</b>	<b>Visit with the personnel from the civil protection agency to some of the areas where the main interventions after the flood event were carried out.</b>
<b>P6 PIETRATAGLIATA UPSTREAM</b>	<p>The relevance of this point refers to the impact over both sides of the Fella river, on the left side 1 house collapsed into the channel due to the extreme widening and incision effects of the 2003 event. On the right side the stability of the road was compromised by the intense erosion over the piles that support the transport infrastructure. This infrastructure included a bridge that had a foundation pile into the river. Therefore, the bridge was reallocated in a wider downstream section of the river without any foundation inside the water channel.</p> <p>Here is also evident that two levels of regional authorities coordinated the reconstruction activities after the 2003 event. The civil protection agency who coordinated the protection works over the left side of the river, the construction and reallocation of the houses affected. One industrial store constructed inside the floodplain and also affected by a previous flash at 1983 flood event was reallocated. The other administrative level is the regional authority responsible for the transport infrastructure, who is still working on the area with equipment into the floodplain still dealing with the protection of the piles.</p>

**Figure 22 and 23.** Upstream view of both sides of the river that covers the ongoing works for the protection of the piles and finilised works on the right side for the protection of the slope channel, disipation of energy and debris retention. December 2011.

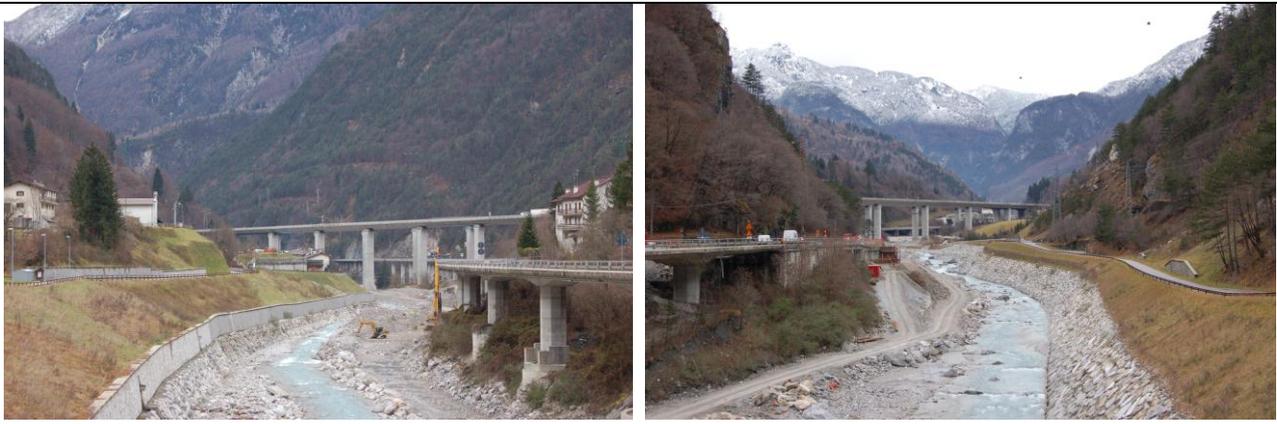
<b>P6 PIETRATAGLIATA DOWNSTREAM</b>	This point corresponds to the location of reallocated bridge next to the confluence of an affluent of the Fella river which also affected a local road which is the only access to small village nearby and that also requires protection and reconstruction works.
-------------------------------------	---

**Figure 24 and 25.** Overview from the bridge perspective of the reconstruction and protection activities after the 2003 event. December 2011.

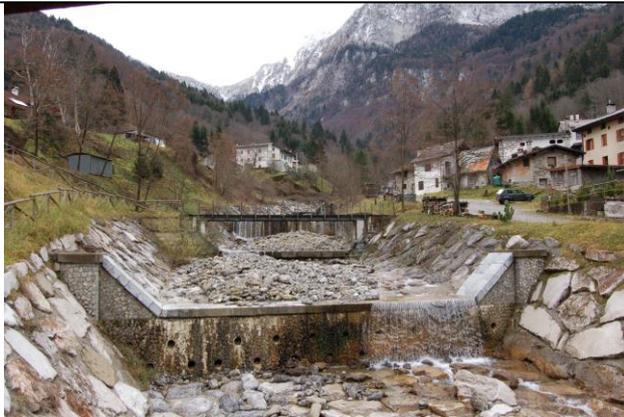
**Figure 26.** (Left) Protection works carried out over the affluent of the Fella river where we can observe the online structures for retention of sediments and slope protection along the stream channel. December 2011.

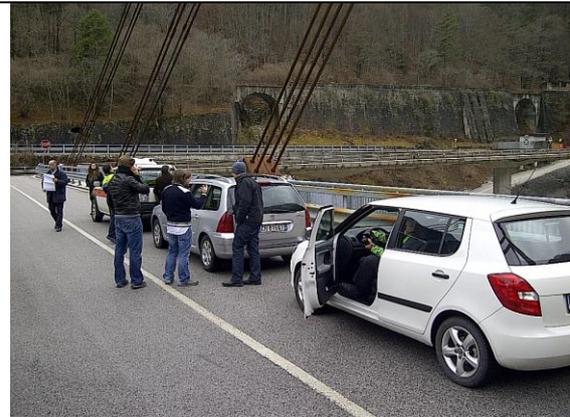
**Figure 27.** (Right) This picture was taken over the reallocated bridge and shows the new type of structure with post-tensed steel cables without intermediate piles. December 2011.

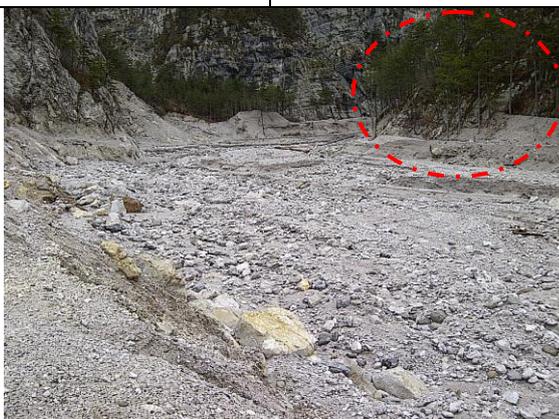
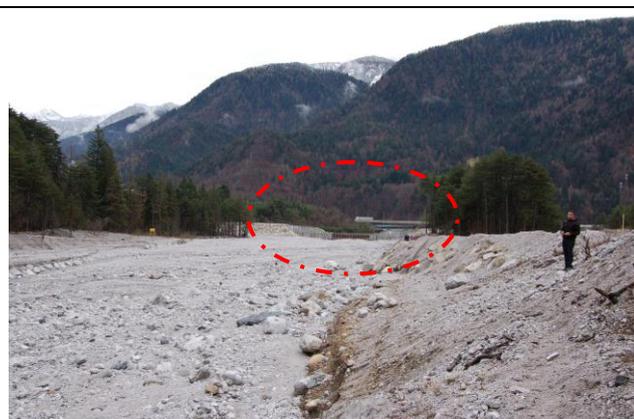
This retention basin for debris was constructed after the event of 2003 as a structural measure to protect the regional road infrastructure several kilometers downstream. The figures below show on the left, signals from the last flash flood event on september 2009 that are still present in the vegetation and fine sediment deposited next to it. On the right, the sectional barriers with fins are visible with a reference person for the scale of the structure. Regular maintenance works are required

**Figure 28 and 29.** Upstream and downstream view of the retention basin constructed after the 2003 event in the Ucceli river in order to protect the regional road infrastructure several kilometers downstream. December 2011.
